**Publisher Name**  
**Product Name**  
**CD-ROM dated 12/27/1999**  
**Sample Report**  
**January 7, 2000**

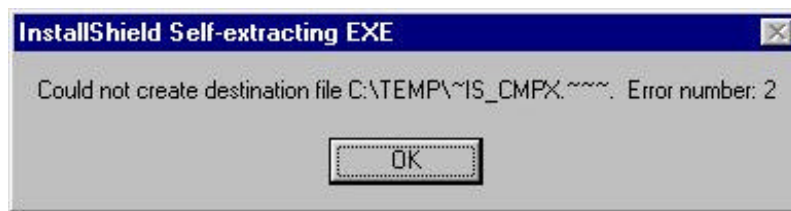
- (2) On one Windows 95 system, we got the error found below when trying to install QuickTime. This was rectified after creating C:\temp.

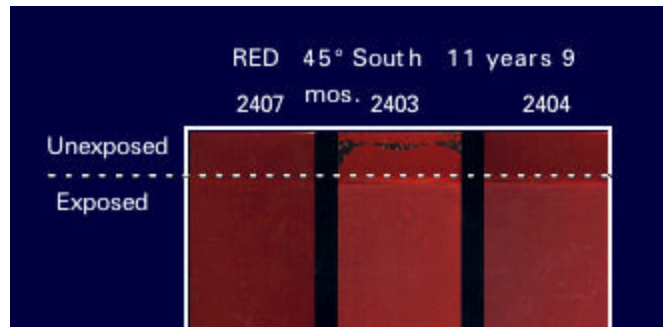
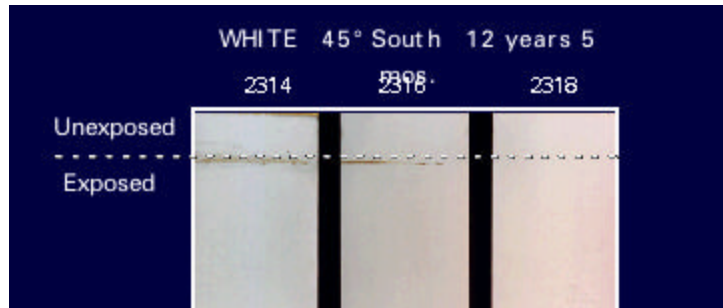
- (1) Under Performance Testing: under the vs FEVE section: on the screens for Red Coating and White Coating: the text showing the exposure time runs onto the next line where it interferes with other text. See the screen captures below. (The other two screens in this section are OK.)

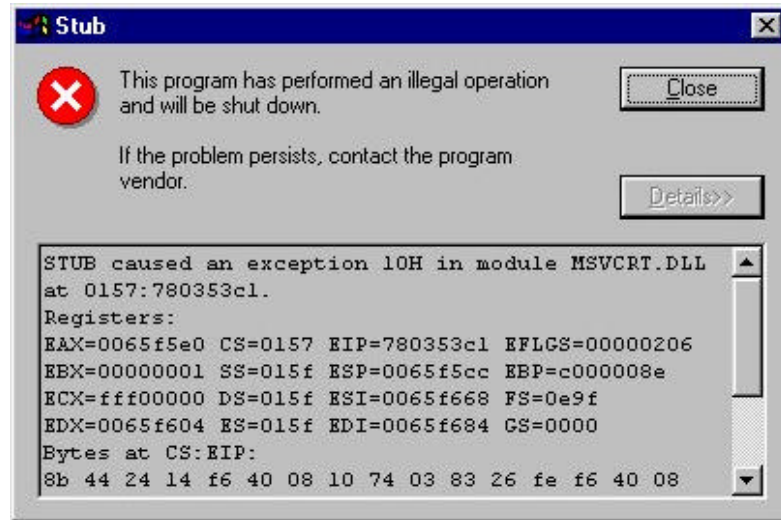
- (1) On seven out of fifteen Windows machines, we were unable to continue beyond the initial introduction screen and got the error message below after the introduction animation ended (or when trying to click through it).

Six of the systems that had the error were Windows 98 systems and the other was a Windows 95 system. We checked several machines just for this error, including some not listed at the beginning of this report. Additional machines that exhibited the error included two new Dell Pentium III systems and one new Micron Pentium III. We could find no pattern involving the version of the .dll file, the version of QuickTime, the operating system, the cards and drivers installed, or anything else about the machines. In fact, one machine that it worked on and one that gave the error were essentially identical machines (HP Brio Celerons). We could not work around the error on any of the machines that gave it.

We suspect that this error could be the result of some conflict between the version of Macromedia Director used and the version of a common DLL file that may be installed by any number of different programs. Being that the conflict on the Micron system was the result of something as common as the installation of HP print drivers, it is likely that many of the users in your target audience will experience the error.
